Case 365 : Narrative

Case Vehicle (A): 1999 Ford
Type: F-150 Lariat, 4 x 4, 4-door pickup
Driver: 62-year-old female
CDC: 12-FZEW-3

CASE NO.: **365-03**
CASE VEHICLE: **1999 Ford**
TYPE: **F-150 Lariat, 4 x 4, 4-door pickup**

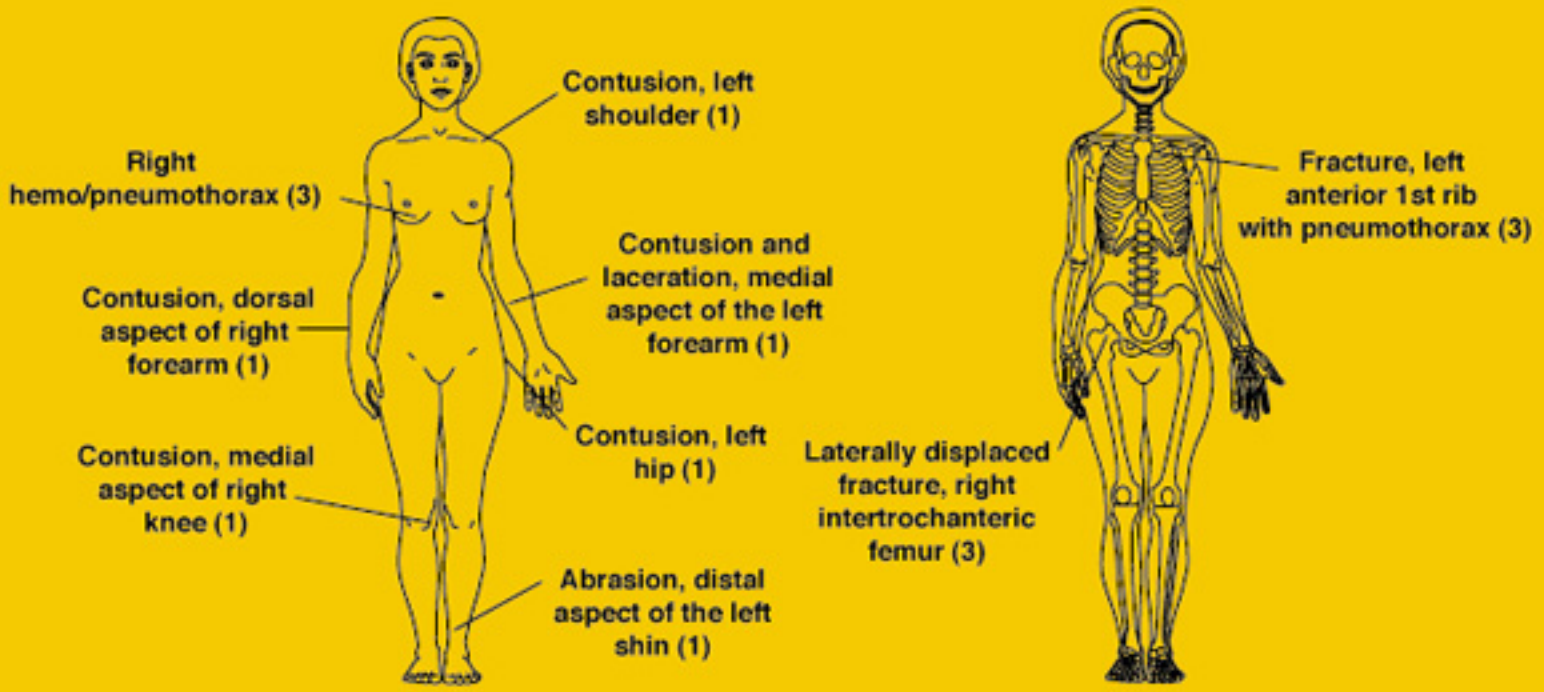
During the frontal impact, the driver moved forward into the belt restraints and airbag. She sustained a fracture to the anterior aspect of the left first rib with pneumothorax, a contusion to the left shoulder, and a right hemo/pneumothorax, probably due to loading by the shoulder belt. She sustained a contusion and laceration to the medial aspect of the left forearm, probably from contact by the deploying airbag and/or airbag module flap. She sustained a contusion to the dorsal aspect of the right forearm, probably from contact with the upper instrument panel, as evidenced by scuffmarks. She sustained a contusion to the left hip, probably due to loading by the lap belt. She sustained a laterally displaced fracture of the intertrochanteric region of the right femur and a contusion to the medial aspect of the right knee, probably from knee contact with the knee bolster, as evidenced by the knee-bolster deformation. She sustained an abrasion to the distal aspect of the left shin, probably due to contact with the brake or parking brake pedal.

The following table and attached drawing 60 summarize the injuries sustained by the driver of case vehicle (A).

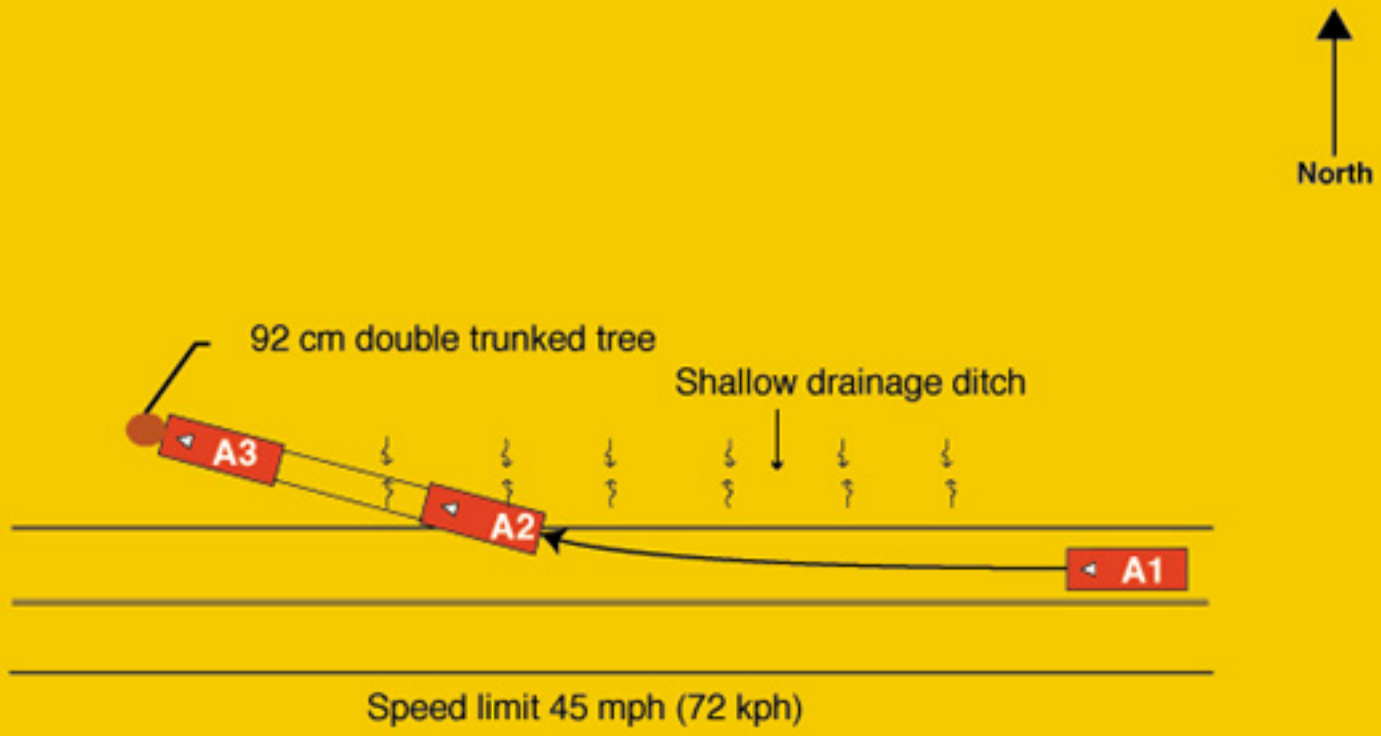
1 It was dark-unlighted and had just started snowing, and the two-lane asphalt road surface was dry and in good condition but with patches of ice, 2 when case vehicle (A) was traveling west in the westbound lane at a driver estimated-speed of 35 mph (56 kph). 3 As case vehicle (A) crossed over a patch of ice, the vehicle began to fishtail. 4 When the rear tires regained traction on the road surface, the vehicle exited the road to the right. 5 The driver of case vehicle (A) reportedly pumped the brakes and then braked hard, but the vehicle 6 struck a 92-cm diameter double trunked tree with the front end.

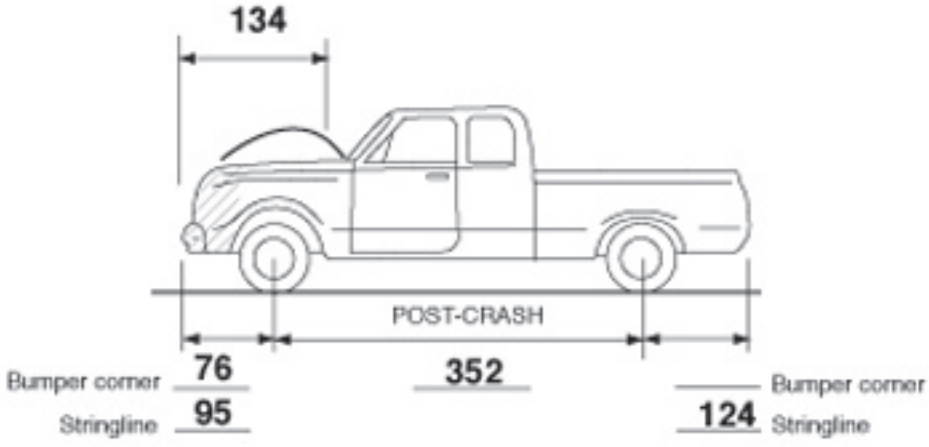
MEASUREMENTS IN CENTIMETERS

Width of direct damage to front

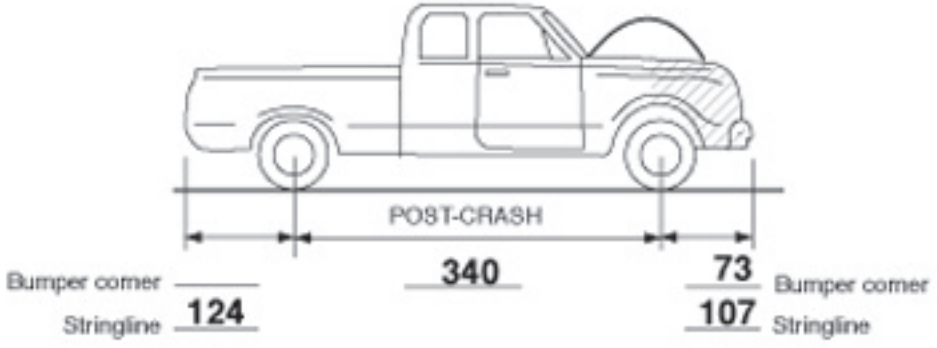
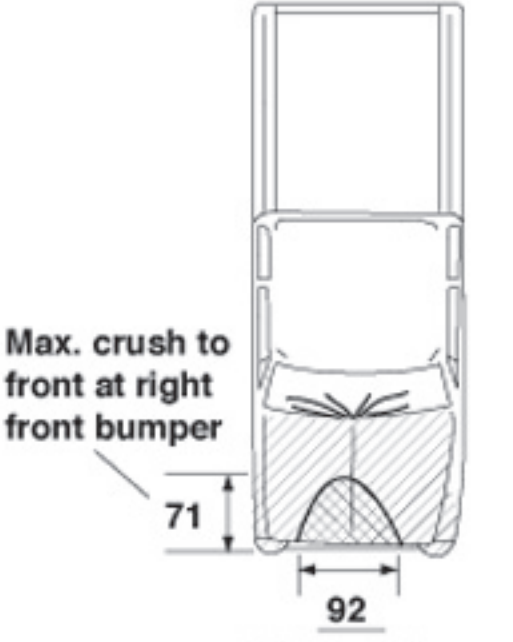
Add 3 cm to front overhangs for measurement adjustment

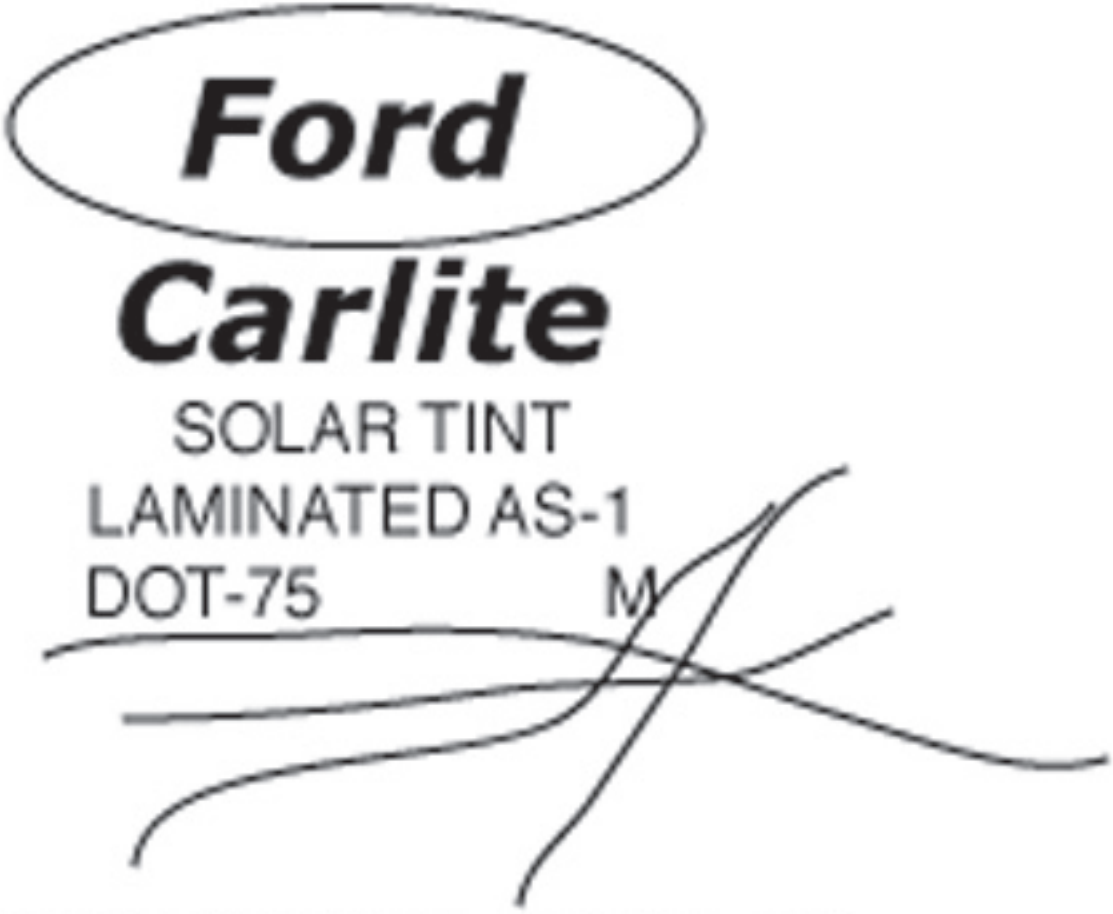
WINDSHIELD MARK ON CASE VEHICLE:

rest of windshield cracked and
mark was unreadable

Windshield cracked in center due to contact by cowl or falling tree branch

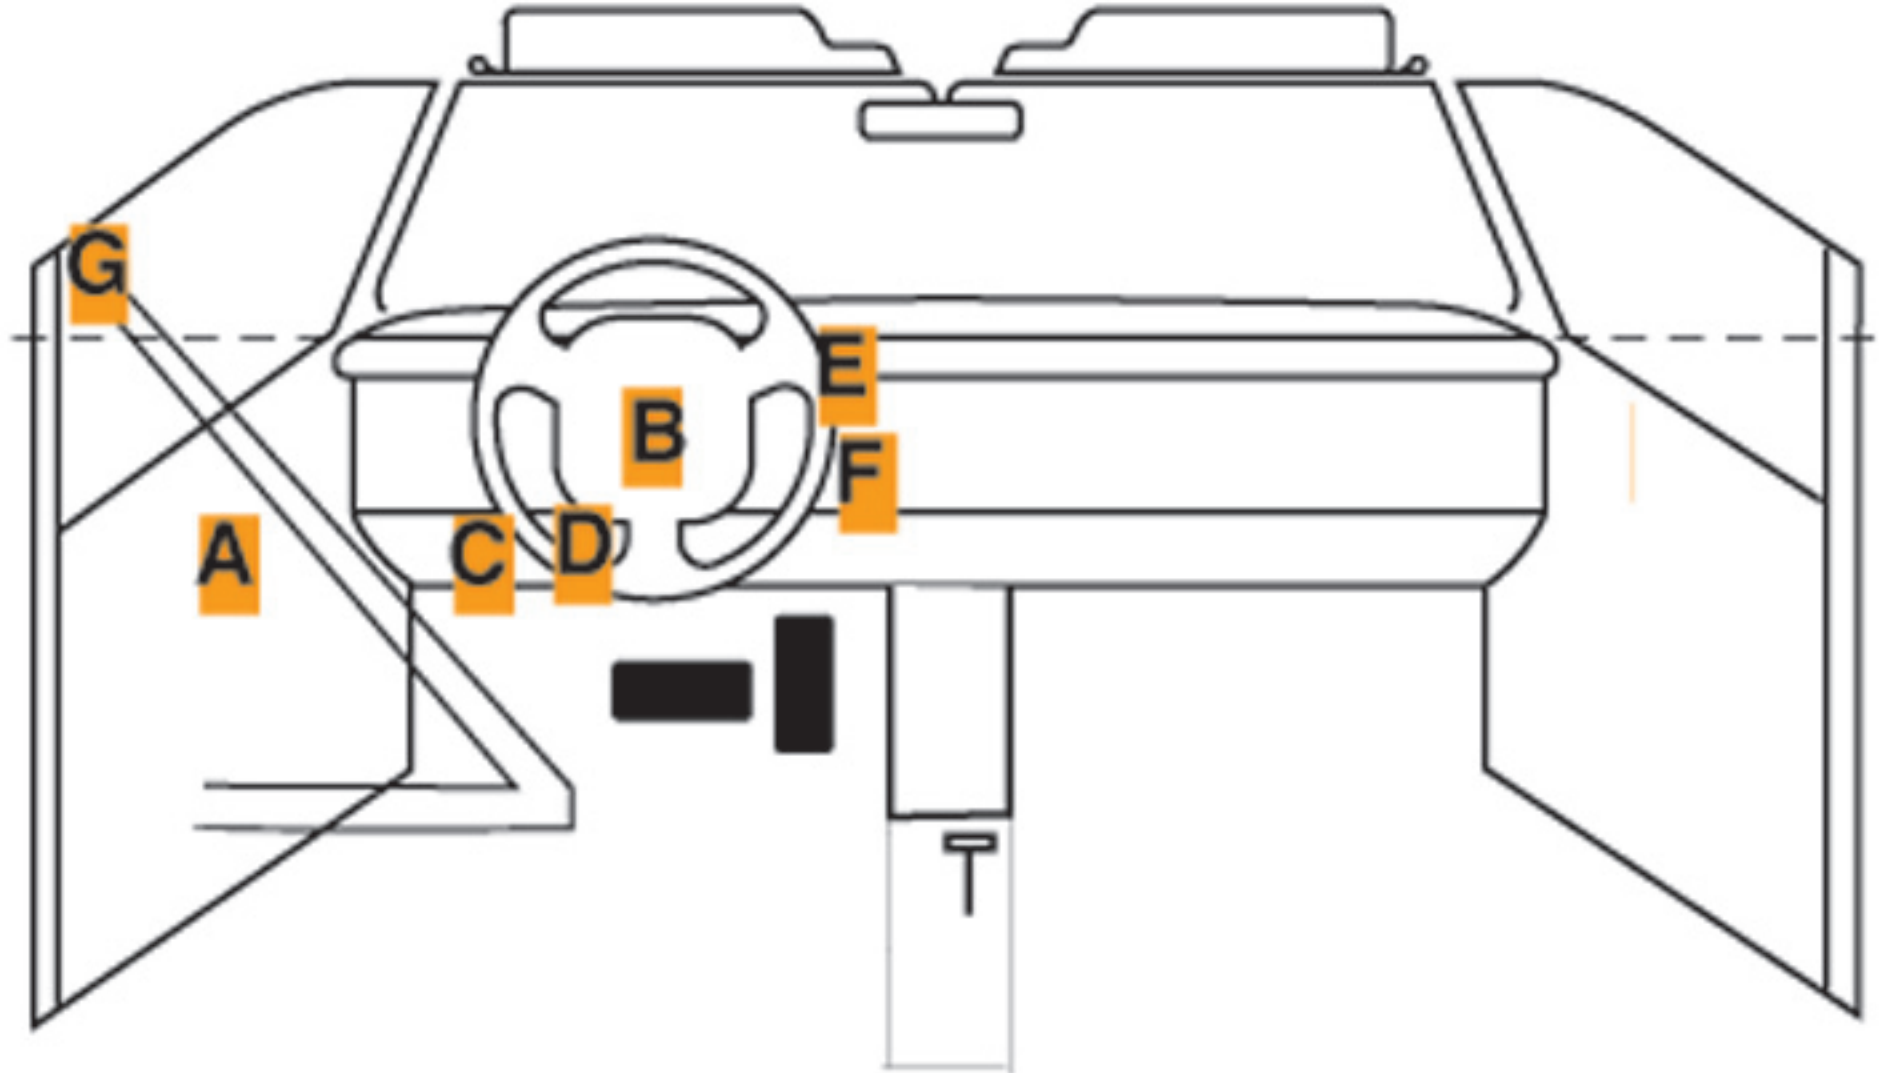
OCCUPANT CONTACT WORKSHEET

A = door hardware, control knobs broken off
B = airbag, blood
C = knee bolster, deformed
D = knee bolster, scuffmark
E = upper instrument panel, scuffmark
F = mid instrument panel, scuffmark
G = shoulder belt, belt imprint on D-ring

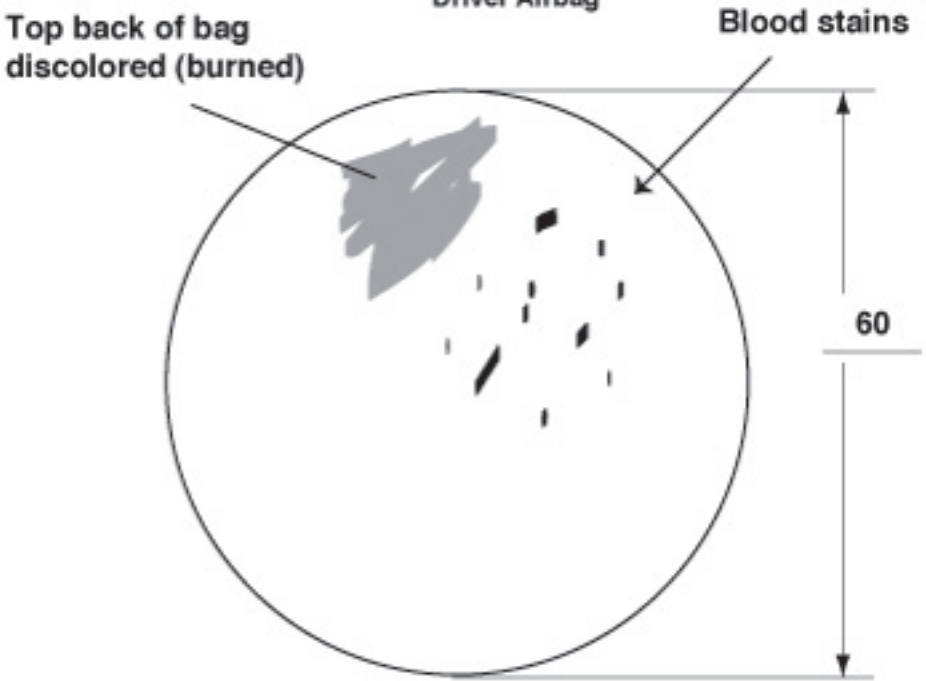
Driver Airbag

upper-rear portion of the steering-wheel airbag was discolored due to heat from the airbag module, and the face of the fabric was stained with blood. 31 The lower-left corner of the upper airbag flap/cover was bent in but 32 there was no damage to the lower flap/cover. 33 34 There was no damage to the steering-wheel rim or spokes and 35 there was no deflection of the steering column. 36 The control knobs on the interior of the driver door were broken off. 37 The fuse-panel cover to the left of the steering column was scuffed and deformed and the knee bolster was scuffed. 38 The upper and 39 mid instrument panels to the right of the steering column were scuffed. 40 41 42 43 There was no other damage in the driver seating area.

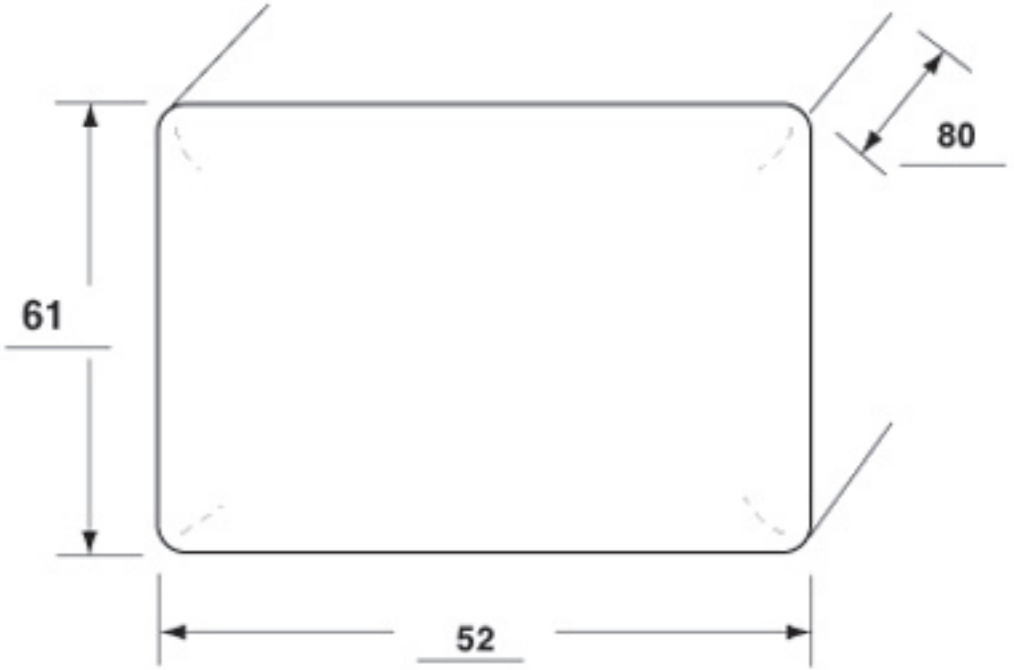
Driver Airbag Doors

Vents: (Y) N

if yes, how many: 2

at 1 and 11 o'clock
